**REZONING SITE PLAN
 (REZ-XX-XX)**

**GILBANE
 HILLSBOROUGH AVE**
 CITY OF TAMPA
 FLORIDA

PROJECT TITLE:
CROSSWIND CHURCH
NEW BUILDING

SHEET TITLE: TREE INVENTORY AND DISPOSITION PLAN REVISION: 1 2 3 5

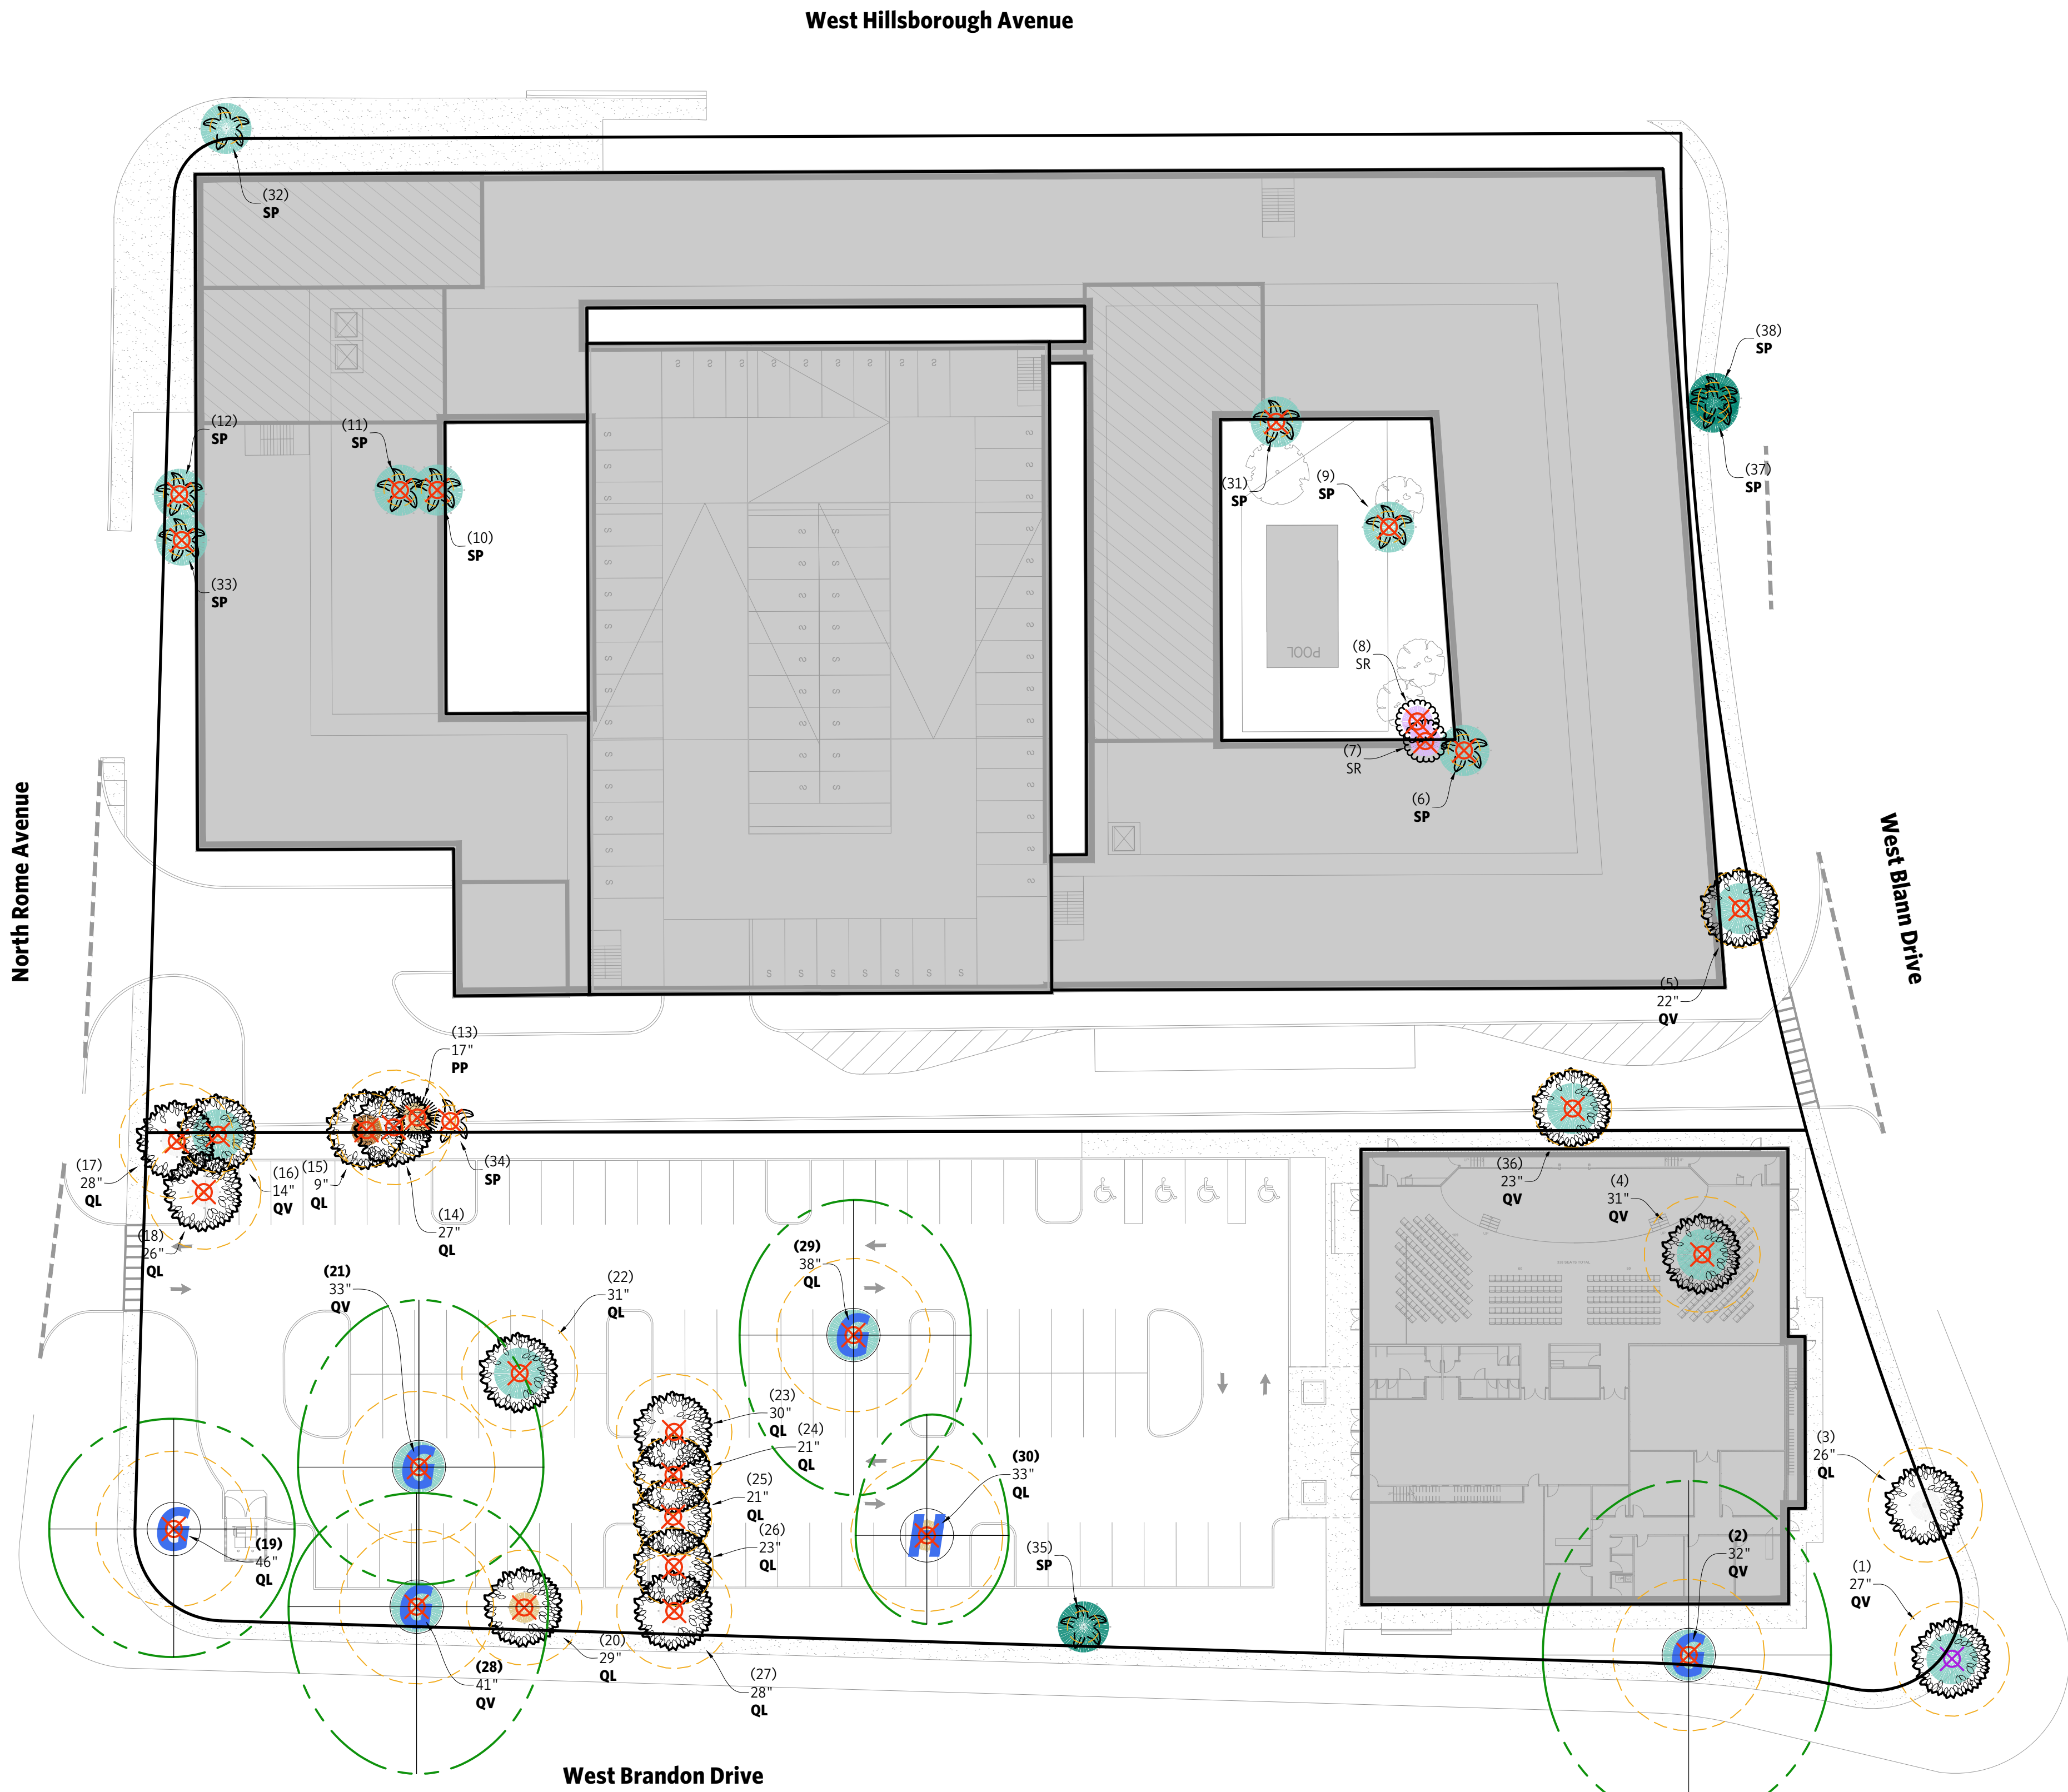
Note: Trees to be removed are marked with a RED x mark. Offsite removals are marked with a PURPLE x mark.

Color representations of Condition Rating are provided as a visual aid. Preservation or removal suggestions are: 1) not recommendations, 2) apply only to onsite trees, and 3) are based on an opinion of preservation suitability near development. Circles are colored by the following convention:

- Dark Green: Excellent (suitable for preservation)
- Light Green: Good (suitable for preservation)
- White: Fair (somewhat suitable for preservation)
- Light Tan: Poor (removal may be warranted unless the consequence of failure is "negligible" or "minor")
- Brown: Very Poor (removal is likely warranted unless the consequence of failure is "negligible")
- Lavender: Category 1 Invasive (removal is usually required per AHJ) or Category 2 Invasive (consider removing)
